ActiveTwo EEG Electrode Service Information:

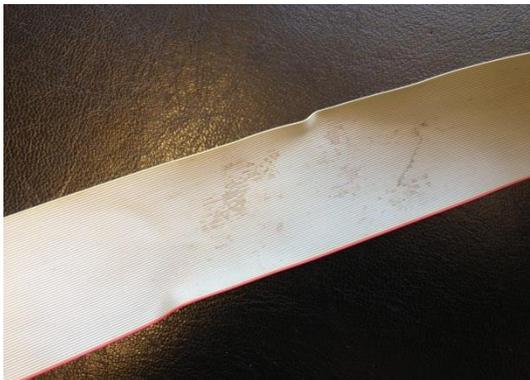
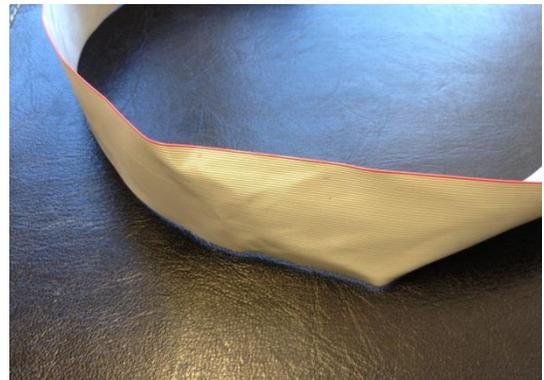
- 1) Serial Numbers starting with **AS04; AS07, FR07, FR09, FR10, FR11** are out of warranty and must be replaced!
- 2) Serial Numbers starting with **FR12, FR13, FR14** are out of warranty but may be repaired if the following conditions are met (**repairs are charged for as per our prices overleaf**):
 - a) The set is in good condition, and only a maximum of 2 electrodes are broken in that set
 - b) The sets were never repaired before
 - c) The sets have been cleansed and unkinked before sending unlike some samples below:

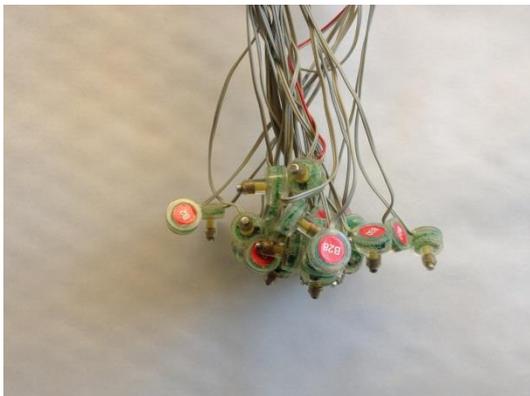
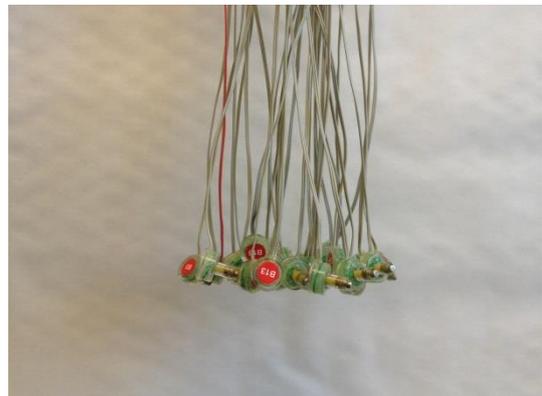
- d) All electrodes are untangled as picture left compares to the right picture:

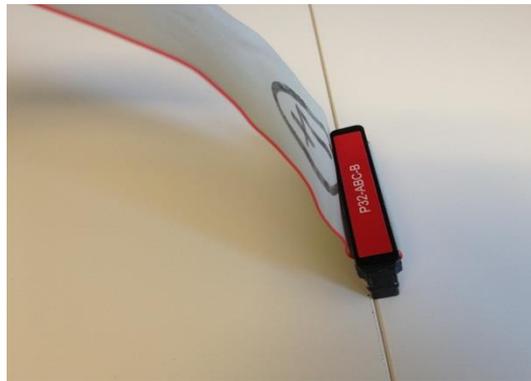
- e) If SCSI connectors attached to the cable have been kinked (this happens when the amplifier sits in front of the subject and so cables have been bent 180 degrees toward the subject) such as pictures below, we will replace the SCSI connector and charge for the service as overleaf:

Please note that kinked SCSI connectors cause intermittent disconnection especially of either the first or the last electrode in that set!

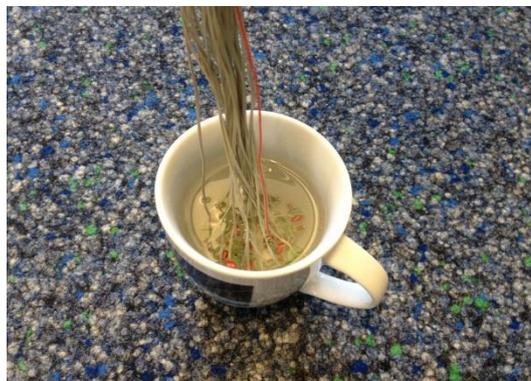
- f) It does often happen, that electrodes have never been cleansed in a water bath properly (see picture below), and so gel hardens on the tips and electrodes then behave very strangely (high offsets, or no changing offsets at all may result from that); if we receive electrodes contaminated with gel, we will charge maintenance fee for cleansing, and checking. We advise before sending, to immerse the entire set in distillate water for around 2 hours and then recheck. See picture below:

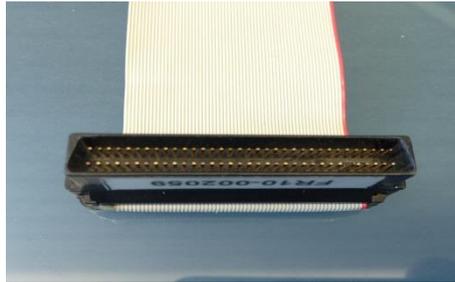
- g) Bent SCSI Pins inside connector or gel bridge near some pins inside the SCSI connector as follows will lead to problems and the defective connector should be replaced (a bent pin is the cause of a user pushing the connector onto the socket to hardly, hence causing bending of the pin. In some cases that even leaves plastic residual in an adjacent hole and so causing quite some problems. Worst case: the SCSI port on the AD Box needs to be replaced) :

Please note that bent pins will show on a channel either a high offset, or cause a short to other channels!
